4. TITLE (and Subtitle) <b>National Program of Inspection of Non-Federal Dams Tennessee. Kagley Dam (Inventory Number TN 00908) near Wellsville, Tennessee, Blount County, TN., Little Tennessee River Basin</b>		5. TYPE OF REPORT & PERIOD COVERED <b>Phase 1 Investigation Report</b>

PHASE I INSPECTION REPORT  
NATIONAL DAM SAFETY PROGRAM

Name of Dam ..... Kagley  
County ..... Blount  
Stream ..... Unnamed Trib. of  
Sixmile Creek  
Date of Inspection ..... May 19, 1981

PHASE I INSPECTION REPORT  
NATIONAL DAM SAFETY PROGRAM  
KAGLEY DAM  
BLOUNT COUNTY, TENNESSEE

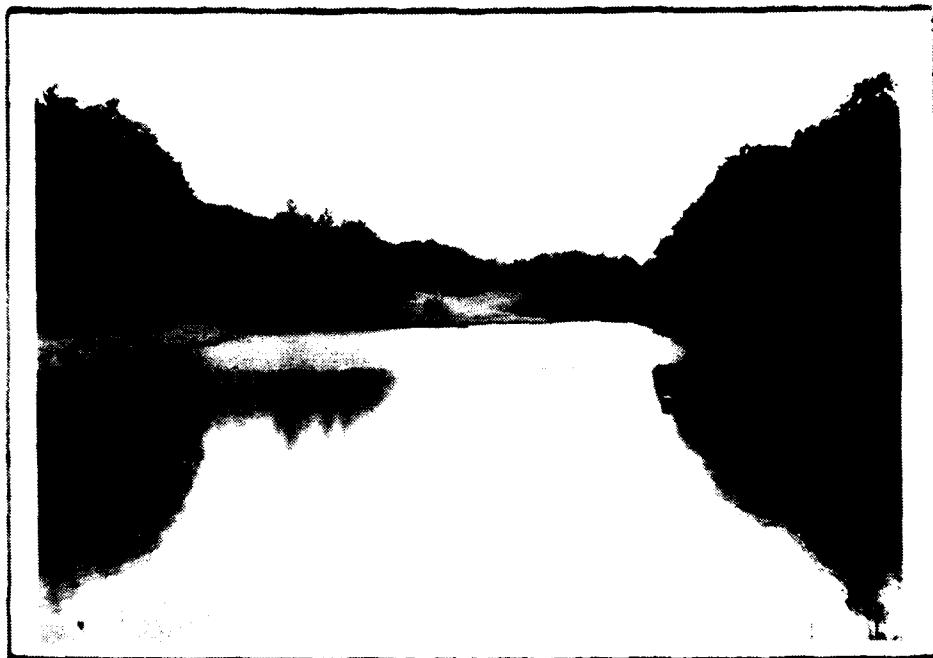
PHOTO NO.1

- Photo No. 1 - View of reservoir from embankment crest.  
Note service spillway riser to the right.
- Photo No. 2 - View of the upstream face and crest from  
emergency spillway entrance channel.

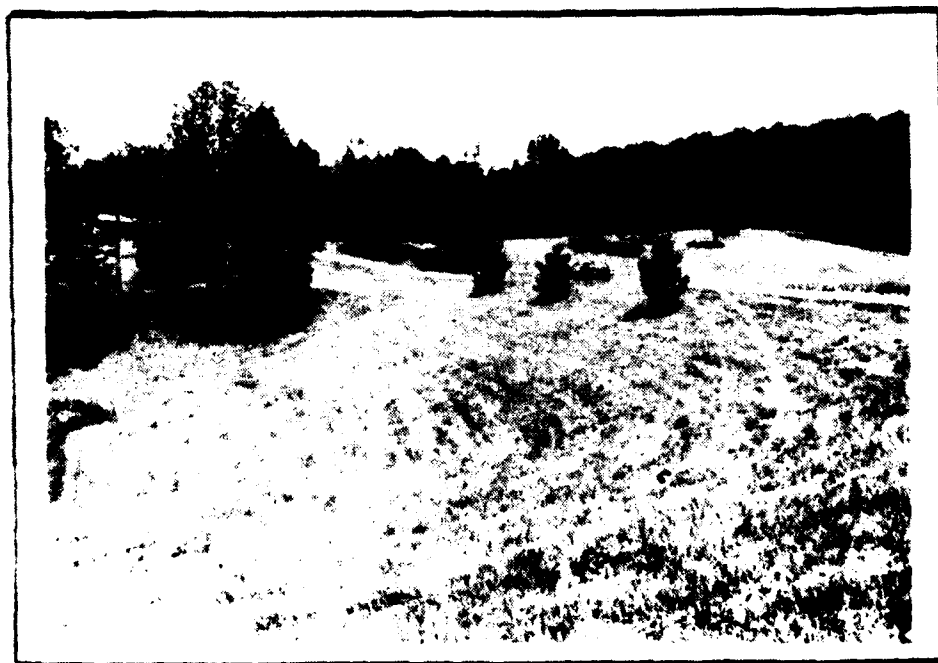
PHOTO NO.4

- Photo No. 3 - View of downstream face. Note hole near toe  
and house in floodplain.
- Photo No. 4 - View of downstream face showing spillway  
exit channel along right abutment.
